Roof Condition Report

9CHB3- Coal Transfer 3

Intermountain Power Service Corporation
850 West Brush Wellman Road
Delta, Utah

June 2001

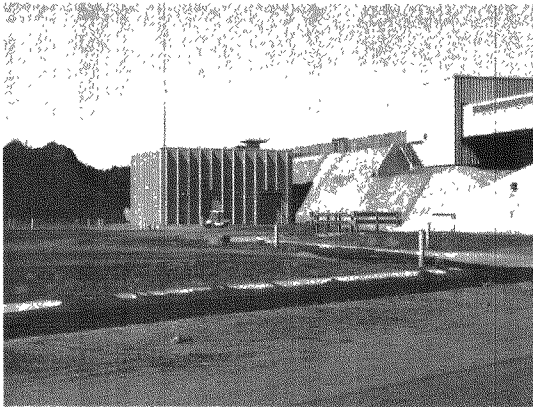
Photo No. 1

The building is behind Coal Transfer Building Two and next to the Conveyor Drive building, seen to the right of the photo.

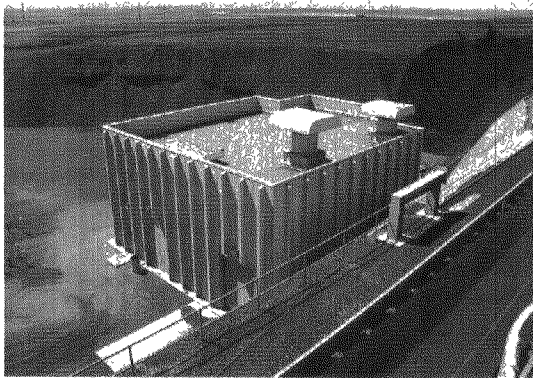
Photo No. 2

The roof is visible from the Conveyor Drive building.

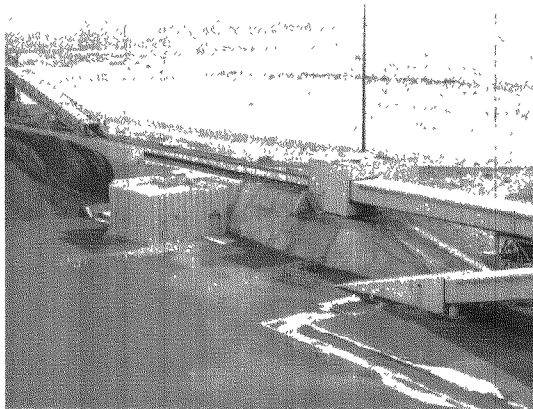
Photo No. 3

The building is shown in the proximity to the Conveyor Drive building, as seen from Coal Transfer Building One.

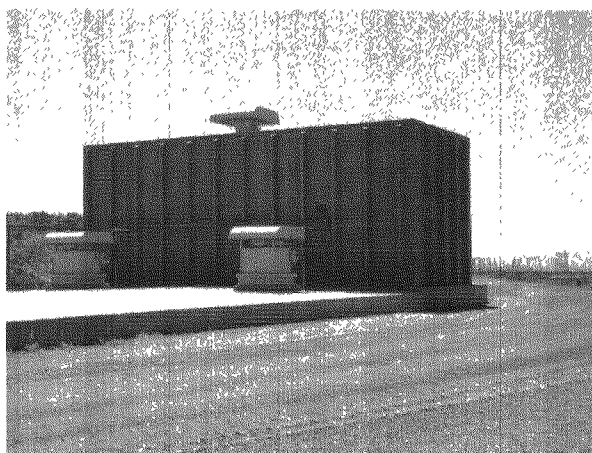
Photo No. 1

The east side of the building, looking west. The lower roof is a concrete slab. Access is by a temporary ladder.

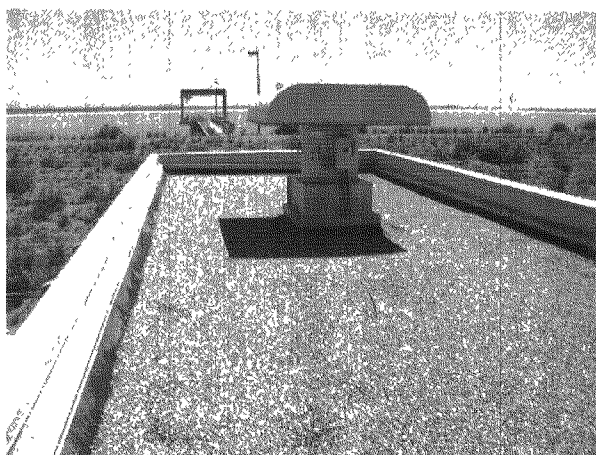
Photo No. 2

The roof of the building, looking south.

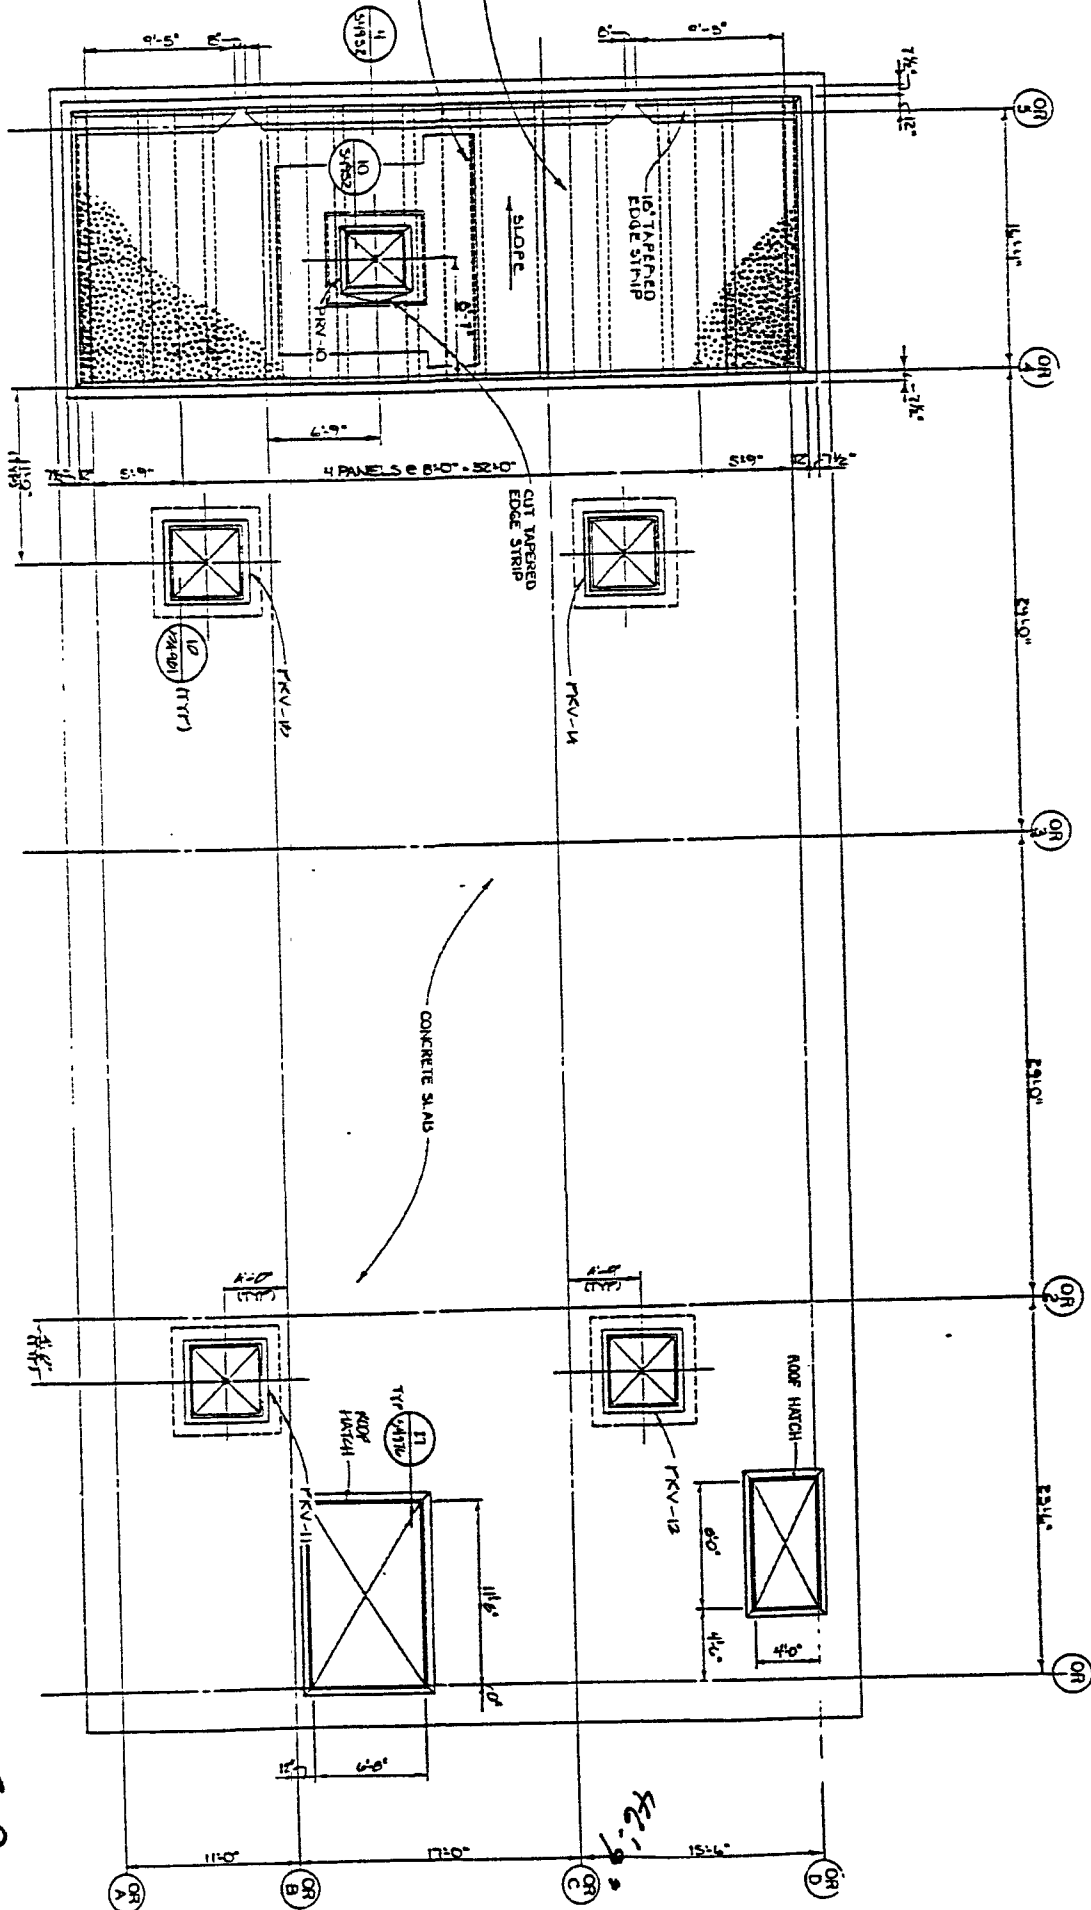
ROOF PLAN

RCI of Section: 65 Rating: MODERATE REPAIRS NEEDED

3. BF-M-2
148 LF Prime exposed and deteriorated base flashing and coat with heavy bodied asphalt coating. [3]
4. BF-H-2
1 LF Install extension of counterflashing over exposed top termination of base flashing. Three course open side laps in base flashing. [4]
